REINFORCED EARTH STRUCTURES

Prácheň – Nový Bor

reconstruction of unstable soil at road I/13 in

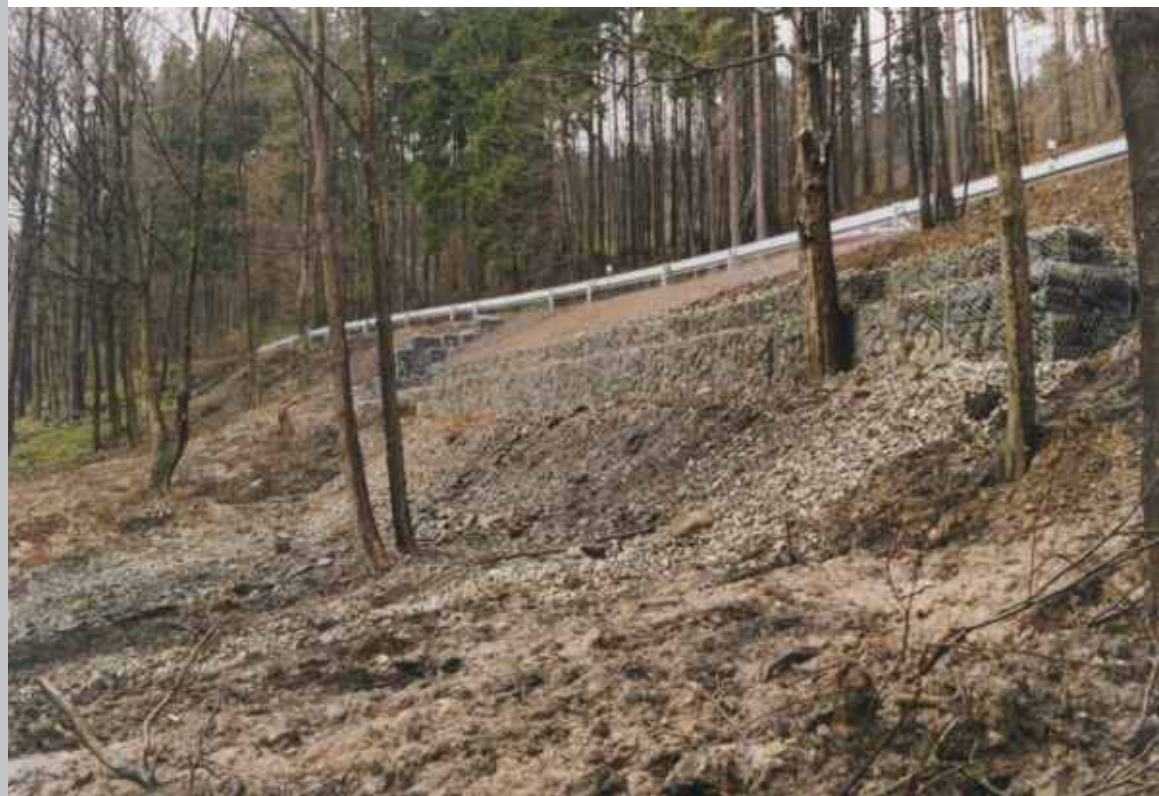
Despite difficult process of work during winter and with the road under full traffic, the slope was repaired with due quality and its esthetic appearance is agreeable, with minimum impairment to surrounding vegetation, as can be seen in fig. 4 and 5. Scheme of the design is displayed in fig. 3, fig. 2 View of the landslide of the road from the accumulation area.

Following excavation of the slipped earth at the toe of the slope down to the original subgrade, the base course was laid reinforcing polyester geotextile **Kortex® GT**, lengthwise direction strength 600 kN/m and 50 kN/m in crosswise direction. The geotextile has a main strength in lengthwise direction to compensate settlement differences as a result of changeable compactibility of subgrade. The toe of the slope is secured by gabion mattresses and the embankment above gabion (steep 1:1) is reinforced by layer thickness of 0.6 m by the **Armatex® G 55/55** geogrid.

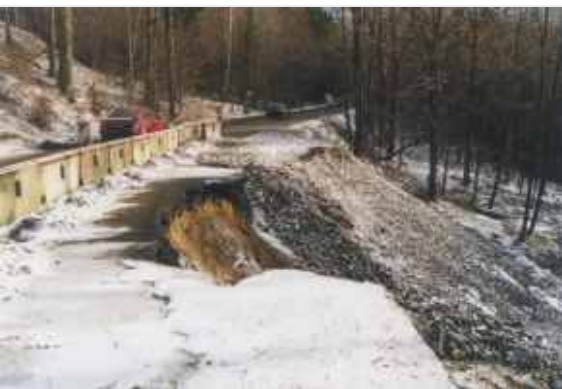
In November 1998, following a heavy rainfall, the road I/13 in the section Prácheň - Nový Bor (see fig. 1 and 2) was damaged. In the given section the road is routed in a rock off-cut. Landslide of the road embankment damaged one half of the way and traffic had to be rerouted to one lane only for both directions, excluding vehicles over 6 tonnes. This fact, however, was not much respected and the risk of other damage was imminent. On this reason the reconstruction had to be undertaken in spite of winter. Considering inconvenient conditions in winter for laying concrete, SG Geotechnika proposed to retain the landslide by using combined effects of reinforced soil and gabions, i.e. not using wet processes.

Fig. 1 Road after slide (11/98)

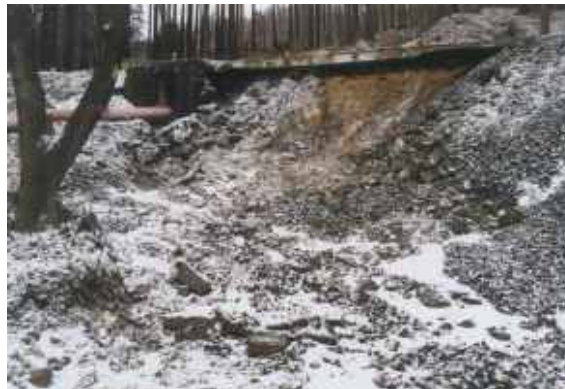
Fig. 2 View of slide of road from storage area

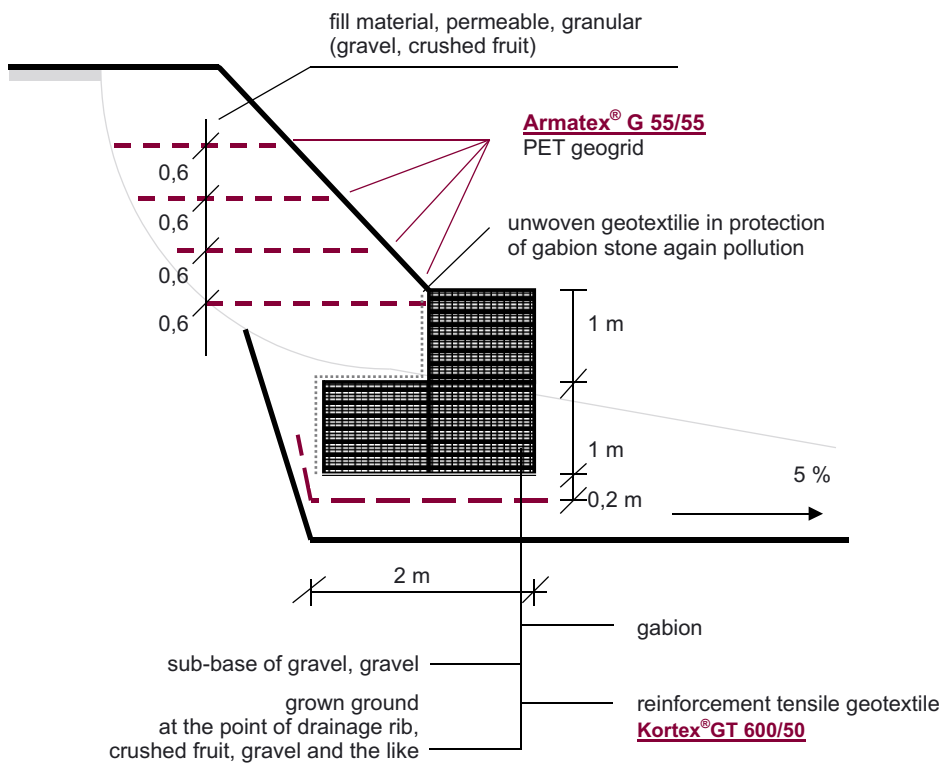
PRÁCHEŇ – slide road I/13 km 162 – 163

CROSS SECTION

Fig. 3 Diagram provision of slide

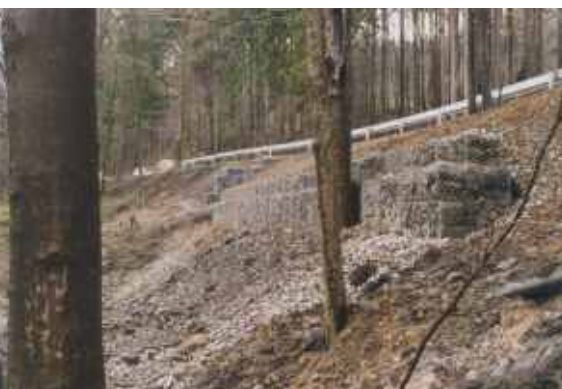
Fig. 4 Slope after maintenance

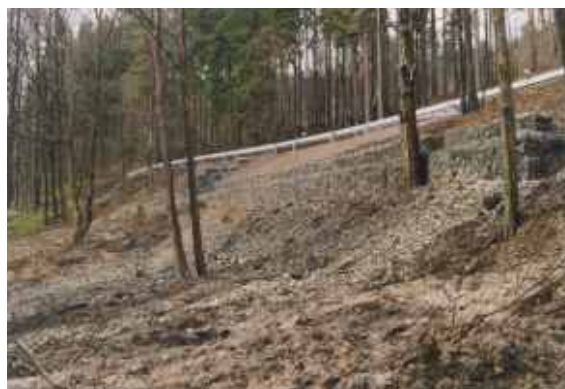
Fig. 5 Slope after maintenance
